**Facility Condition Assessment Services**

**Tier 1 Report of  
Facility Condition Assessment**

**For  
City of Los Altos  
Classrooms 7-9  
97 Hillview Avenue  
Los Altos,  
94022-3740**

**Date of Report: June 10, 2016**

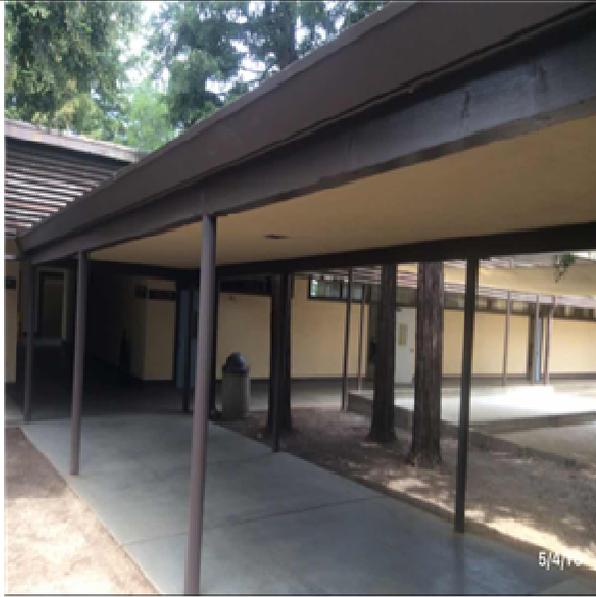
B1023 Canopies:- View of Canopies - Wood Joists Supporting Exterior Grade Plywood

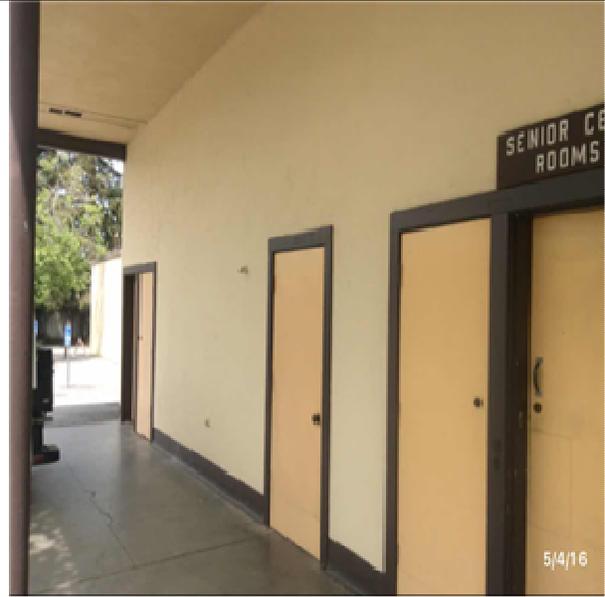
The stucco appeared to be in fair condition with no instances of deterioration observed. We do however recommend repainting of exterior surfaces later in the study period to maintain the appearance of the building and also protect the asset.

B2011 Exterior Wall Construction:- View of Stucco over stud walls

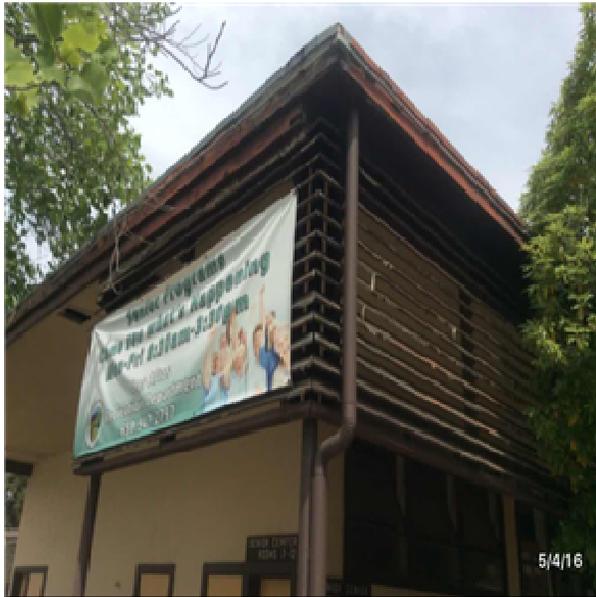
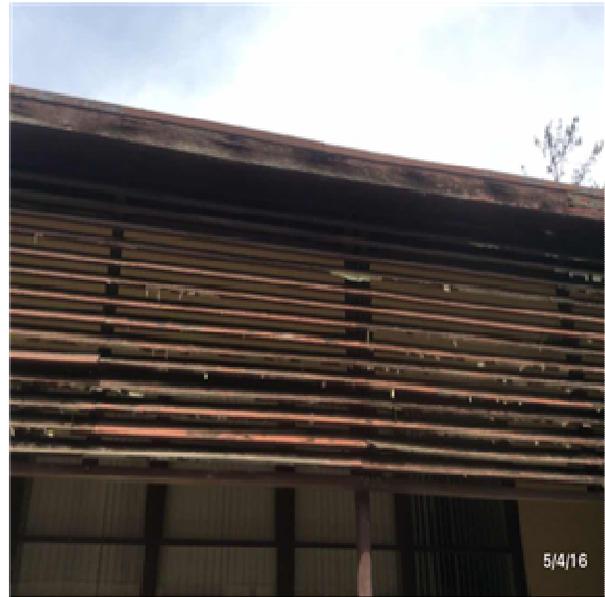
B2014 Exterior Sun Control Devices:- View of Exterior Sun Control Louvers

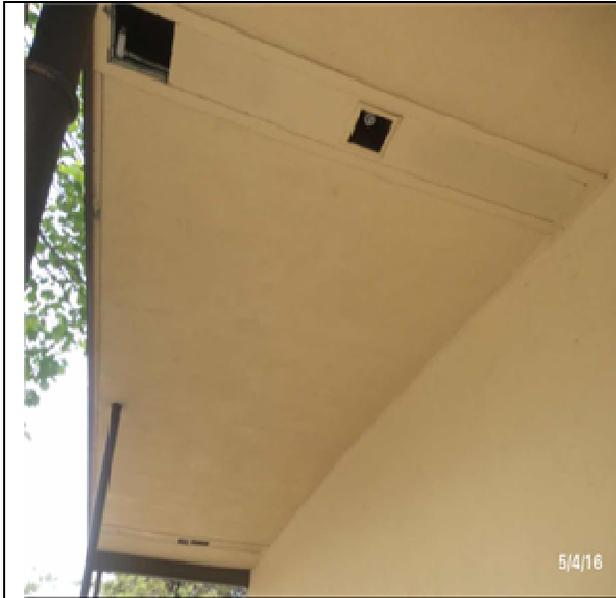
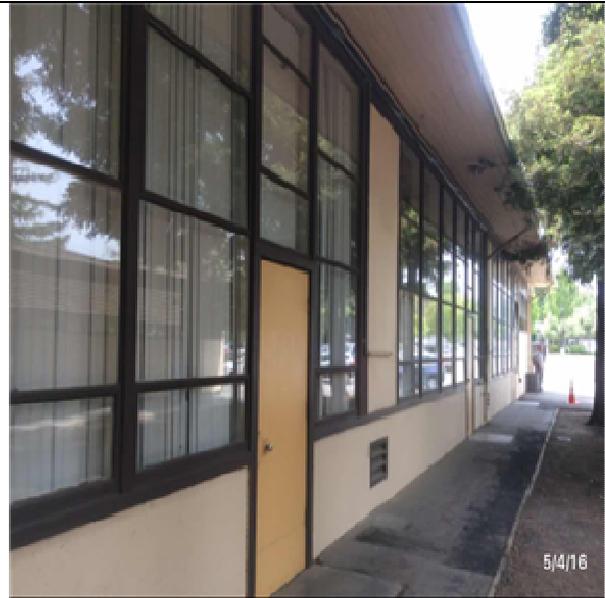
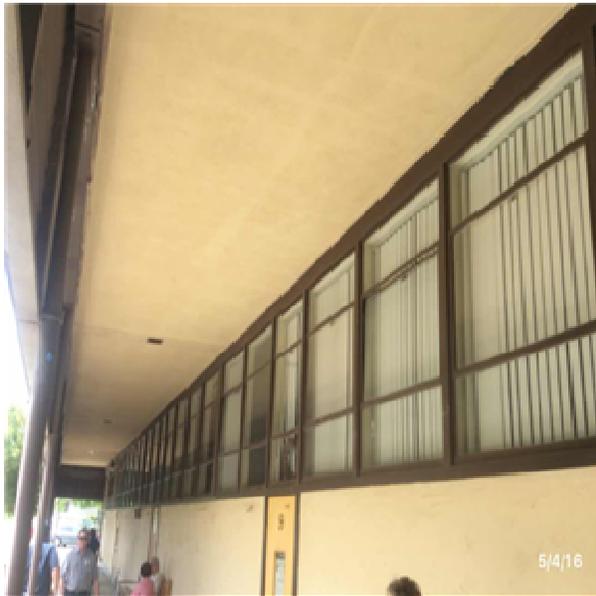
The exterior soffits appeared to be in fair condition; therefore we do not anticipate any actions during the study period. We do however recommend repainting of these surfaces later in the study period to maintain the appearance of the building and also protect the asset.

B2016 Exterior Soffits:- View of Exterior Soffits

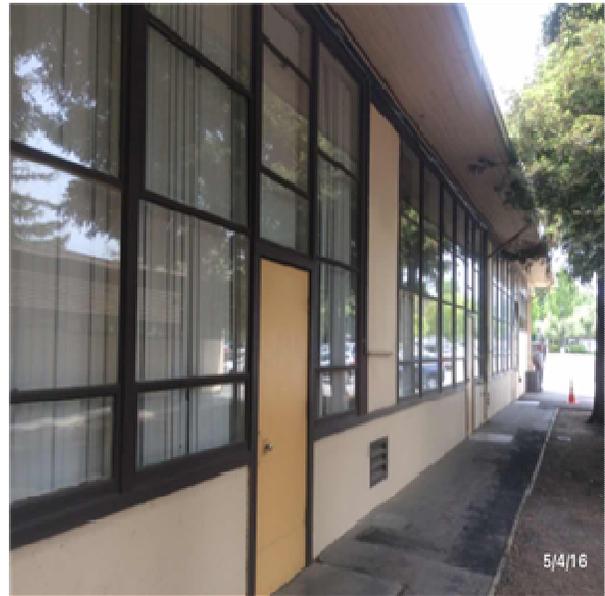
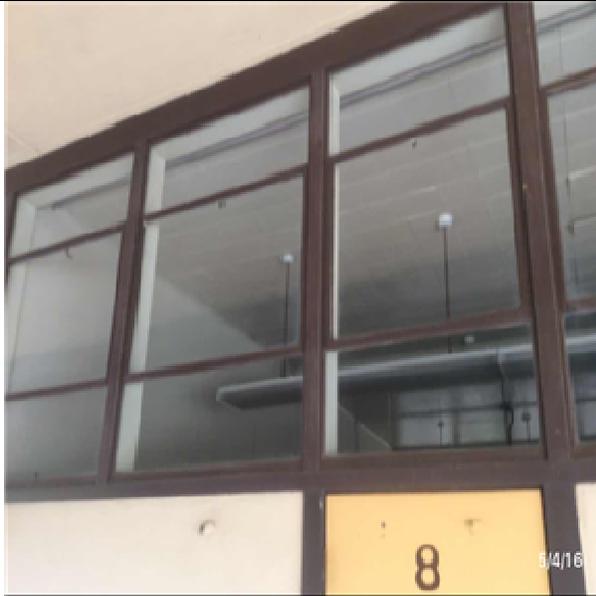
The windows at the building were observed to be in poor condition. We have assumed the windows to be original based on the current condition, which would put the windows well past their useful life. Glass has been replaced recently due to difficulty of operation, and the frames showed signs of rust and corrosion. We recommend replacing the window immediately in order to maintain the appearance and security of the building as well as prevent water penetration.

B2021 Windows:- View of Steel Window Units - Casement, Double Hung, Vent or Sliding

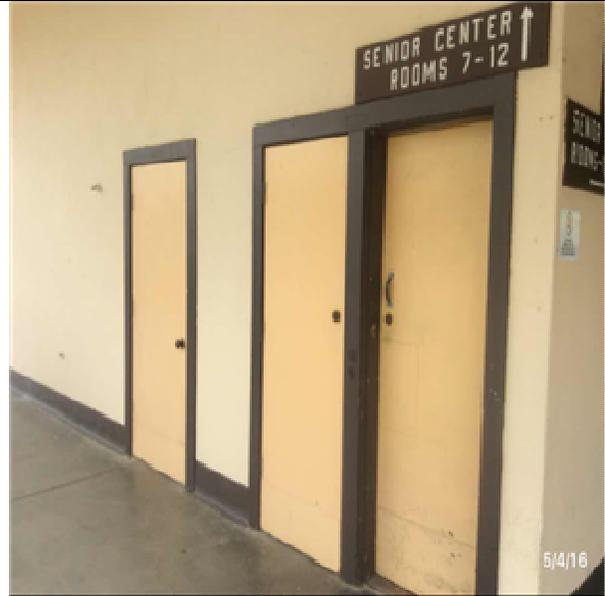
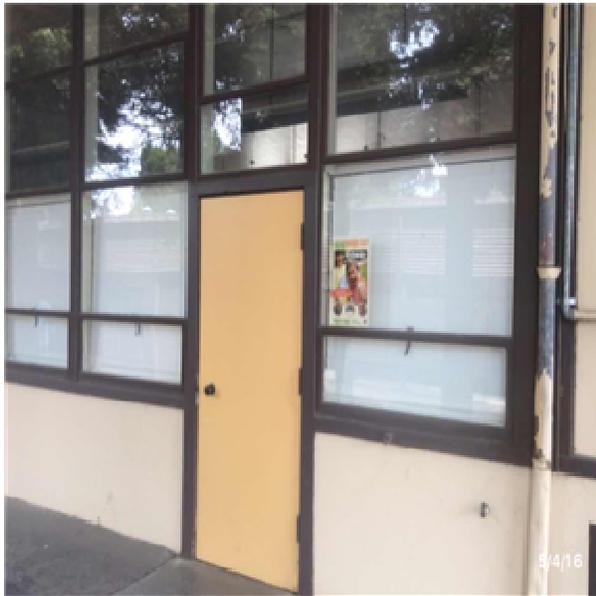
The wood doors at the building were observed to be in poor to fair condition. We have assumed the doors to be original based on the current condition, which would put the doors well past their useful life. Some doors have been repaired but there are signs of degradation. We recommend replacing the doors immediately in order to maintain the appearance and security of the building as well as prevent water penetration. The new door surface finish and door frames will require repainting later in the study period. The cost of this work has been included within the amount to undertake the repainted of the exterior walls.

B2032 Solid Exterior Doors:- View of Single Solid Core Wood Doors

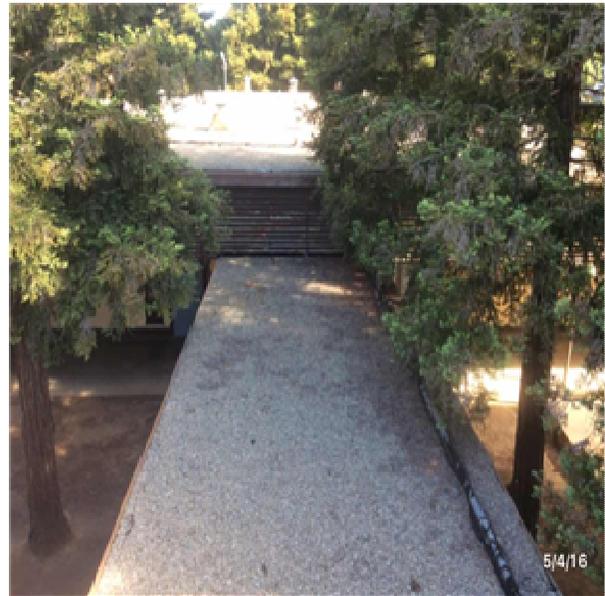
The BUR covering appeared to be in poor to fair condition with no reported leaks, however there is deterioration due to age and other similarly aged roofs to the Community Center have already been repaired. We are unaware of the age of the roof covering, however we assume it to be more than fifteen years of age, therefore based on the typical EUL of twenty years for this type of covering and current observed condition, we anticipate replacement early in the study period.

B3011 Roof Finishes:- View of BUR (Built-up Roofing) Covering to canopy

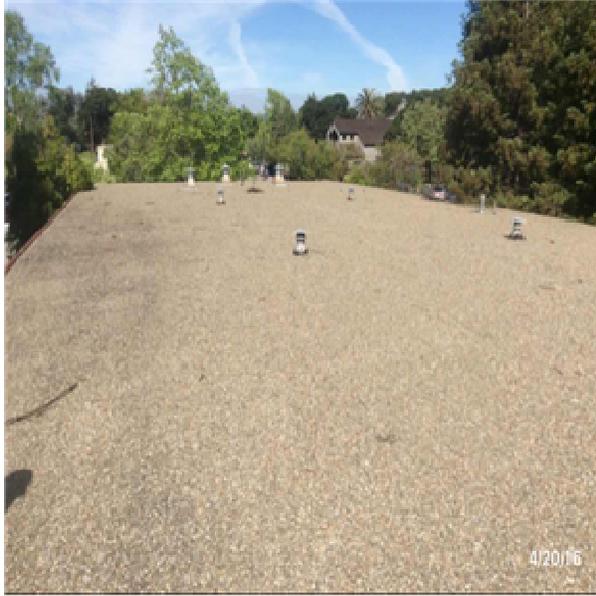
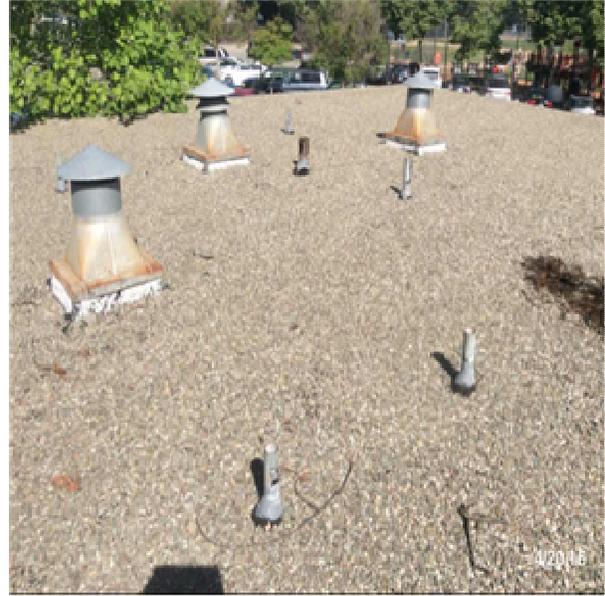
The BUR covering appeared to be in poor to fair condition with no reported leaks, however there is deterioration due to age and other similarly aged roofs to the Community Center have already been repaired. We are unaware of the age of the roof covering, however we assume it to be more than fifteen years of age, therefore based on the typical EUL of twenty years for this type of covering and current observed condition, we anticipate replacement early in the study period.

B3011 Roof Finishes:- View of BUR (Built-up Roofing) System

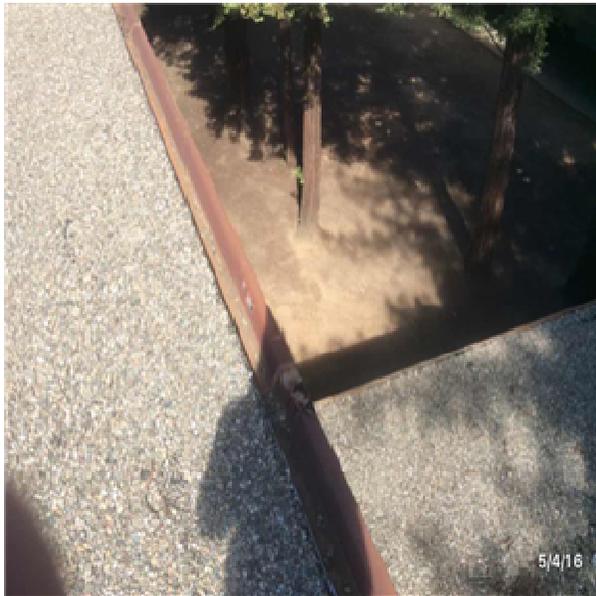
The gutters appear in poor condition. Maintenance personnel reported that the gutters and down spouts are difficult to maintain due to the fact that they are connected directly to the below ground drainage. The typical EUL for this type of gutter system is twenty years; therefore, we recommend replacing the gutters and downspouts at the beginning of the study period.

B3016 Gutters and Downspouts:- View of Galvanized Steel  
Perimeter Gutters & Downspout

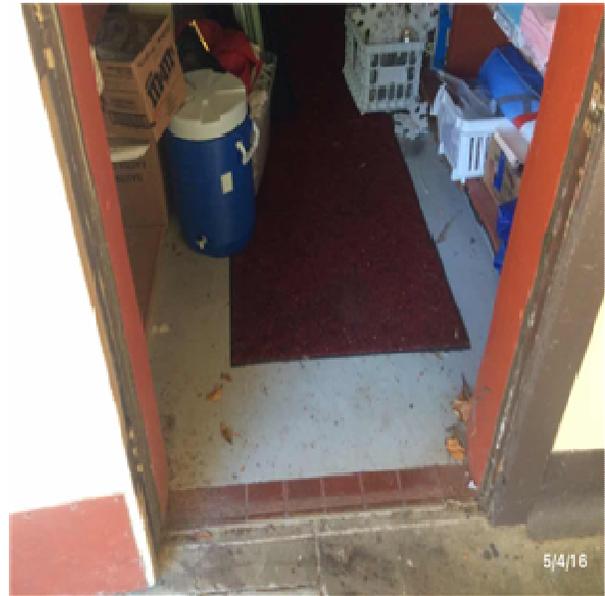
C3023 Hardeners and Sealers:- View of Epoxy Floor Coating

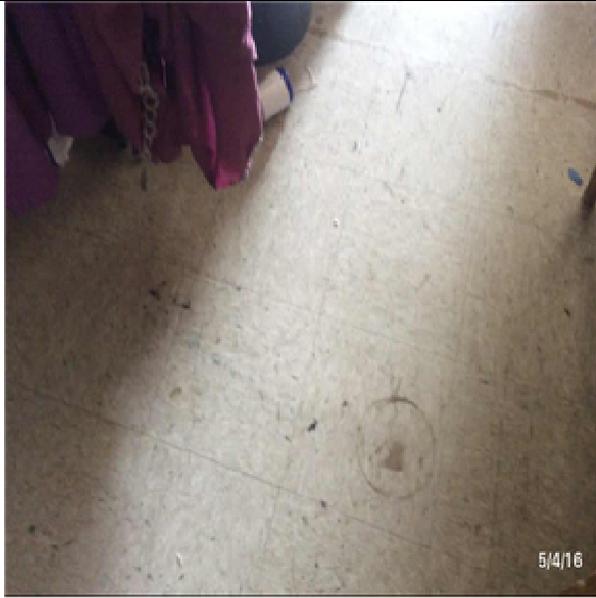
The floor finishes appeared in poor - fair condition throughout the building. We are unaware of the age of the epoxy floor covering at the storage areas, however we assume it to be more than fifteen years of age, therefore based on the typical EUL of ten years for this type of covering and current observed condition, we anticipate replacement early in the study period. The vinyl tile have a EUL of eighteen years; however, considering the observed condition, we have extended the RUL on this flooring to later in the study period.

C3024 Flooring:- View of Vinyl Composite Tile (VCT)

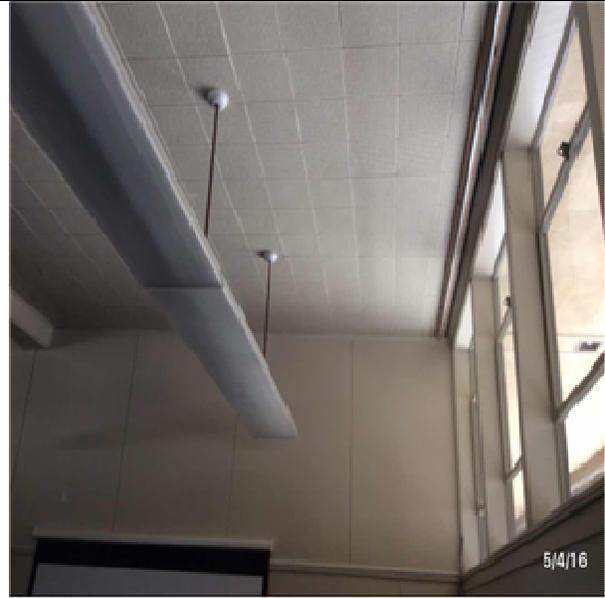
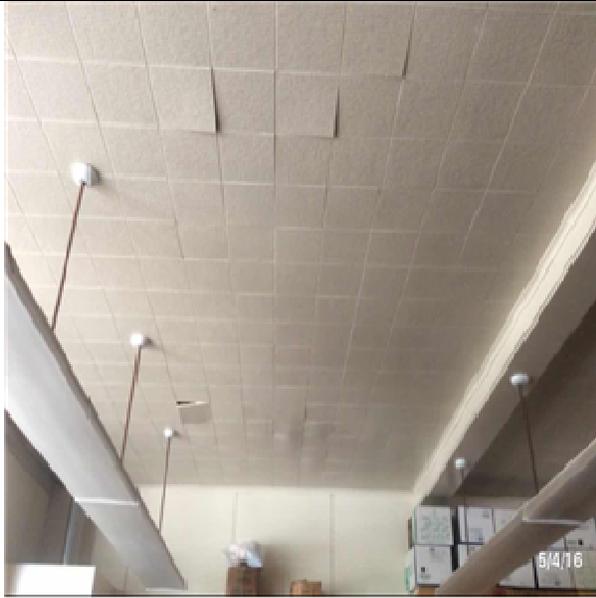
C3032 Suspended Ceilings:- View of Acoustic Ceiling System - Standard

C3032 Suspended Ceilings:- View of Acoustic Ceiling System  
- Standard

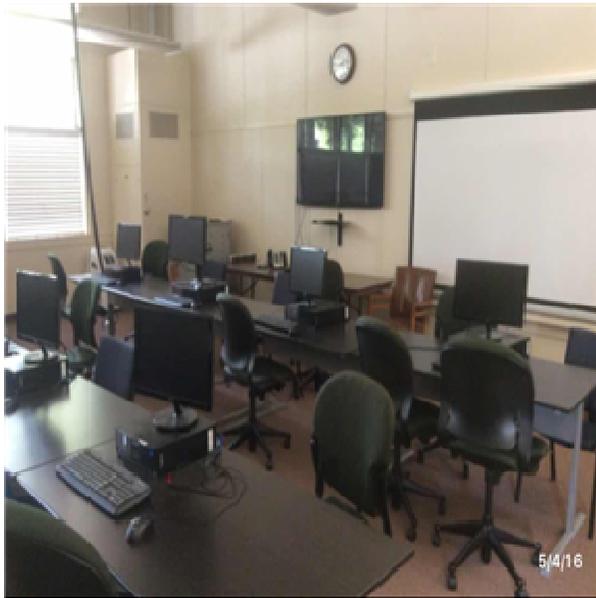
C3025 Carpeting:- View of Broadloom Standard without Padding

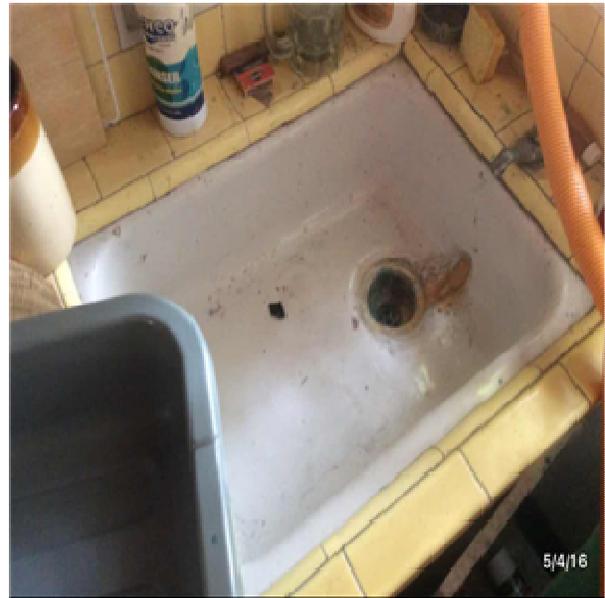
The lavatories were observed to be in poor condition; however, they are no longer used and therefore not included in the study period.

D2013 Lavatories:- View of Vanity Top Lavatories

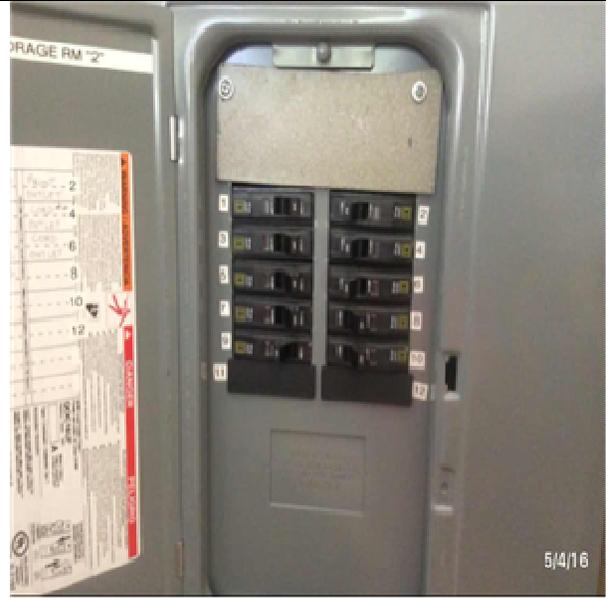
D5012 Low Tension Service & Dist:- View of Panelboard -  
120/208volts, 200amp

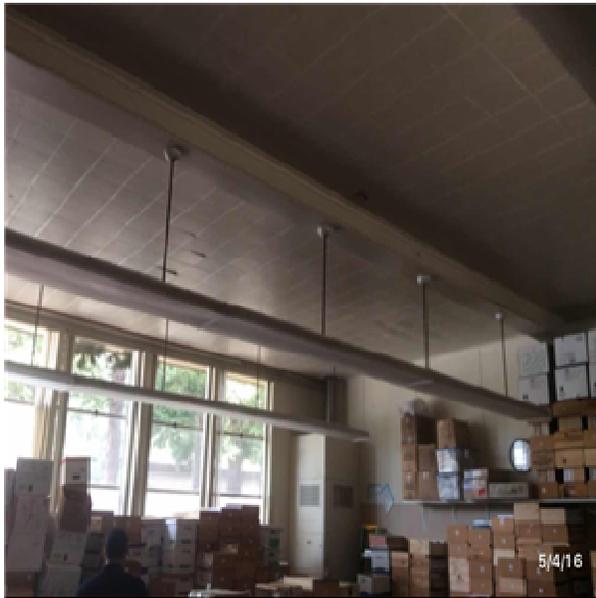
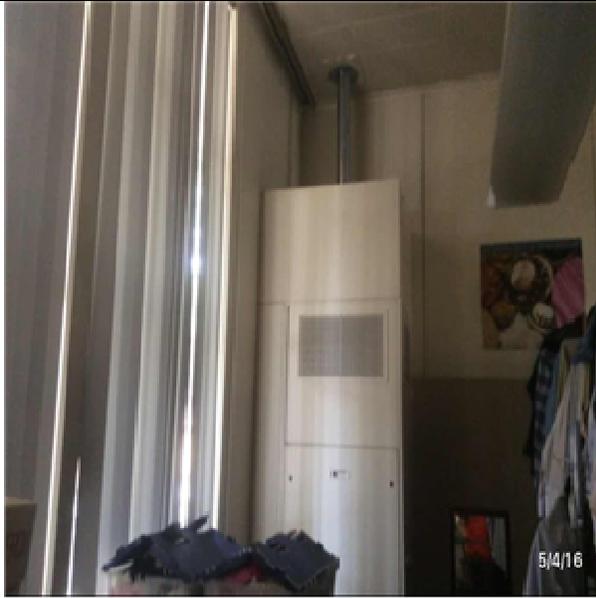
D3021 Boilers:- View of Furnace - Gas

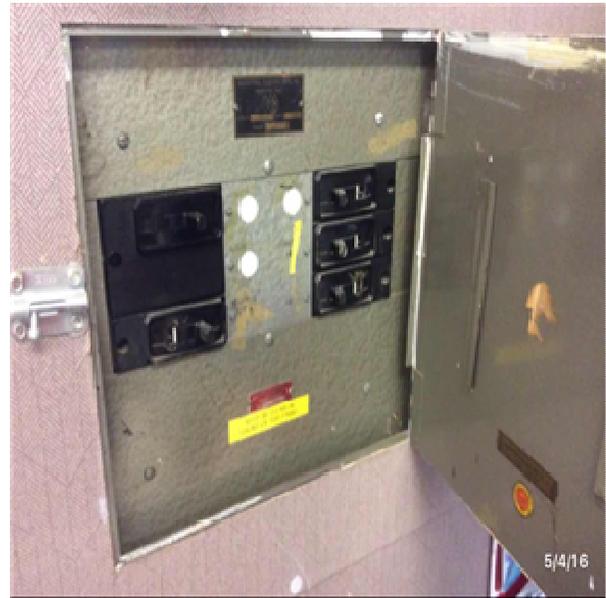
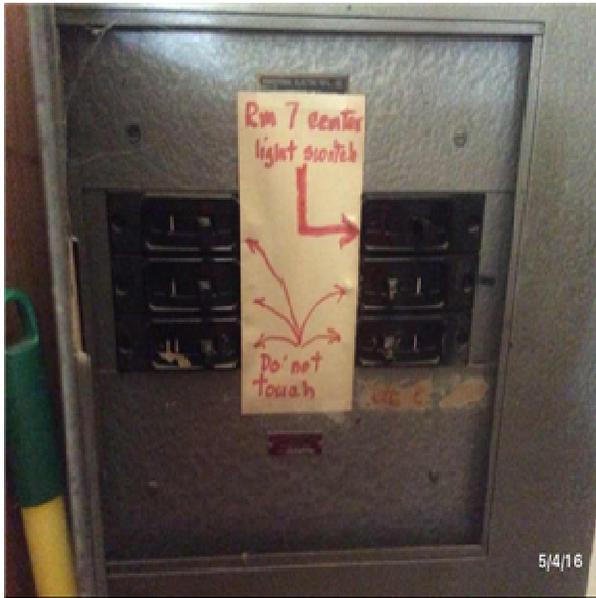
D5012 Low Tension Service & Dist:- View of Panelboard -  
120/208volts, 60amp

D5012 Low Tension Service & Dist:- View of Panelboard - 120/208volts, 60amp

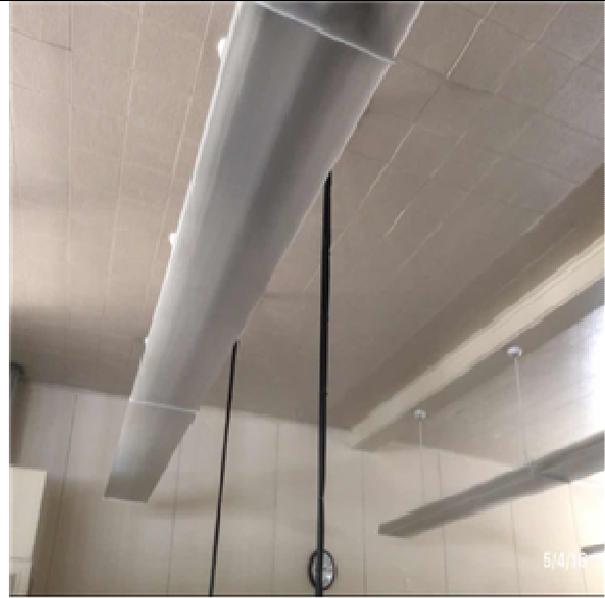
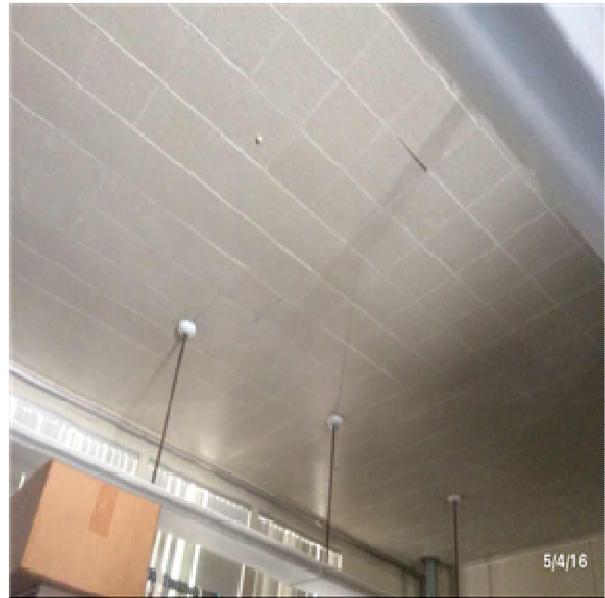
D5022 Lighting Equipment:- View of Interior Light Fixtures - Fluorescent
